UNITED STATES ENVIRONMENTAL PROTECTION AGENCY
Region I - EPA New England

SUBJECT: CAA Partial Compliance Evaluation of Saint Gobain Performance Plastics Corp.
Merrimack, New Hampshire

A. Date of Inspection: May 13, 2015

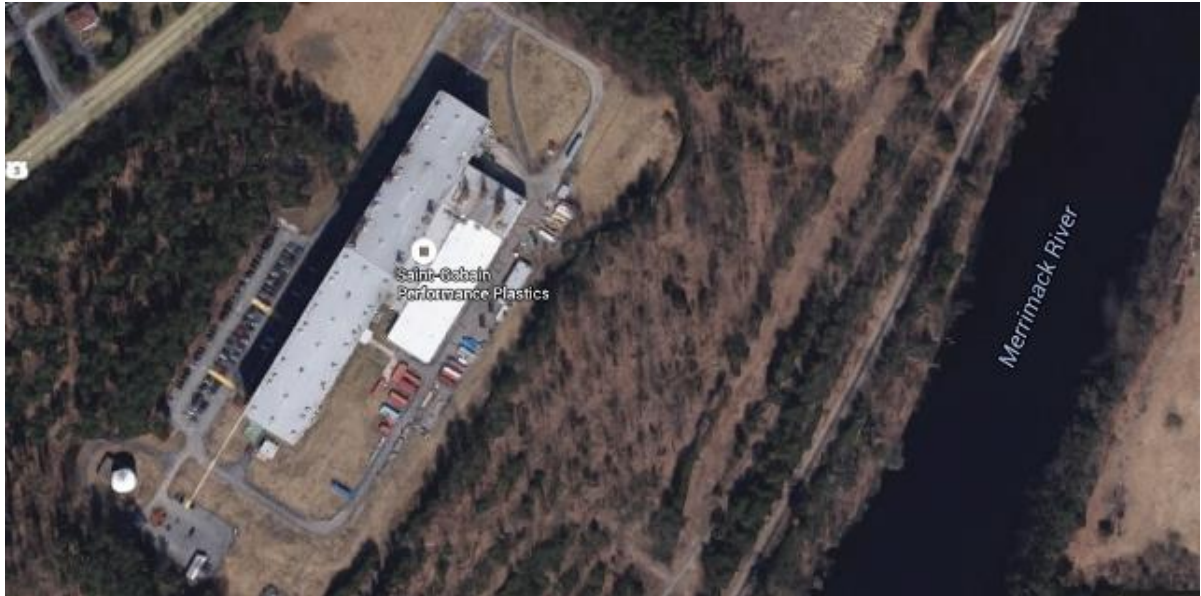
Site Overview

SGPP operates in a 3-floor 225,000 square feet building on a 20 acre site. The production area is on the 1st floor with offices and laboratories located on the 2nd and 3rd floors. The facility is located adjacent to the Merrimack River on the southeast-side of the property. The facility is located in a commercial area. A railroad is located between the building and the river on the southeast-side. A residential neighborhood is located approximately 1200 feet away.

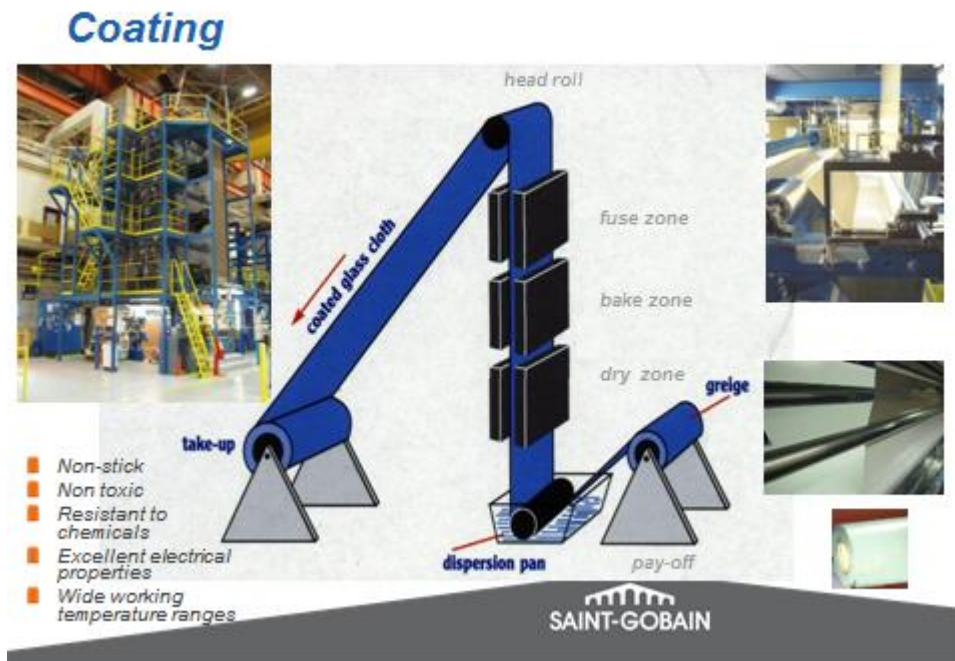
The woven fiberglass is unrolled in a fabric coating machine. It is then dipped into a coating tank, vertically raised and thermo set and dried in three natural gas-fired oven zones. The first zone is called the fusing zone with a temperature of 500 to 550°F. The next zone is the baking zone. The final zone is the drying zone with a temperature of 1,250°F. Below is a pictorial of the coating process.

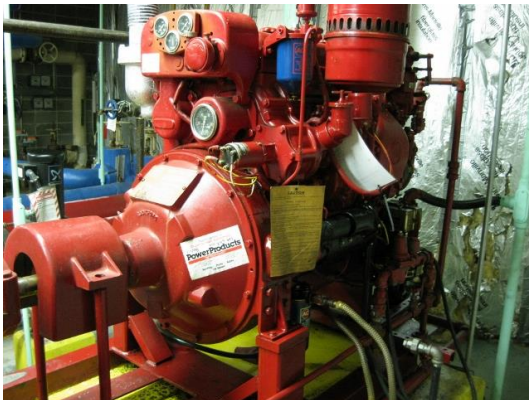
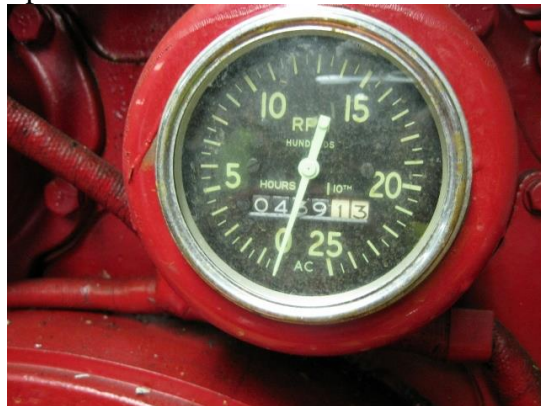
Fire Pumps

Inside the Pump House were two diesel-fire pumps that only operate if a fire occurred in the plant. The 160 horsepower (1.10 MMBtu/hr) pumps burned #2 fuel oil at a rate of 8.0 gal/hr. The operating hour meter on one of the pumps read 469 hours.

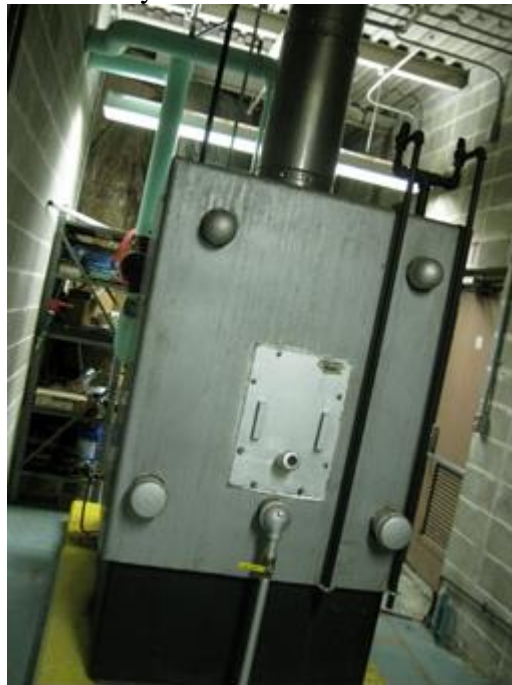
Bryan Hot Water Heater

Additionally, inside the Pump House was a hot water heater with a capacity 225 horsepower (1.56 MMBtu/hr) that also burns diesel fuel. The Bryan burner model number is L-28WT-FT. The hot water is used to circulate the water in the winter to the water storage tank maintained for plant water and fire emergencies. The facility is currently installing a freshwater line from the town into the plant that would make the tank and heater obsolete. The facility plans to take the hot water heater out of commission by the end of the year. The Inspector suggested that the facility amend its permit to exclude the hot water tank when it is taken out of commission. Next to the Bryon burner was a Preventive Maintenance Program (see above).

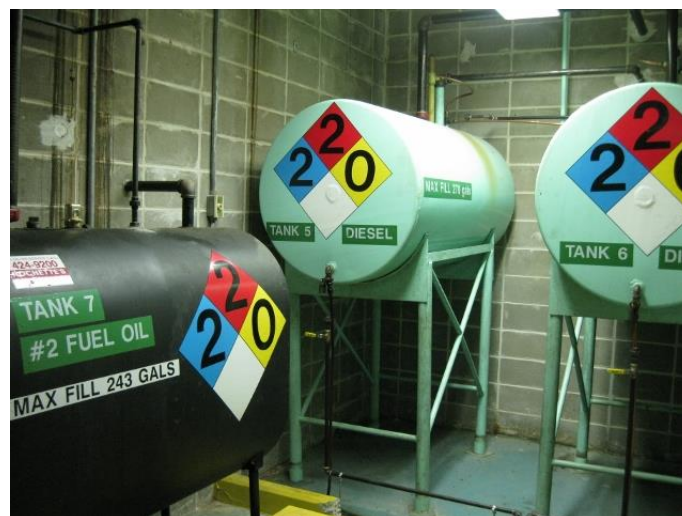
Diesel Fuel Storage Tanks

Diesel storage tanks were maintained in the Pump House for the Fire Pumps and Hot Water Heater.

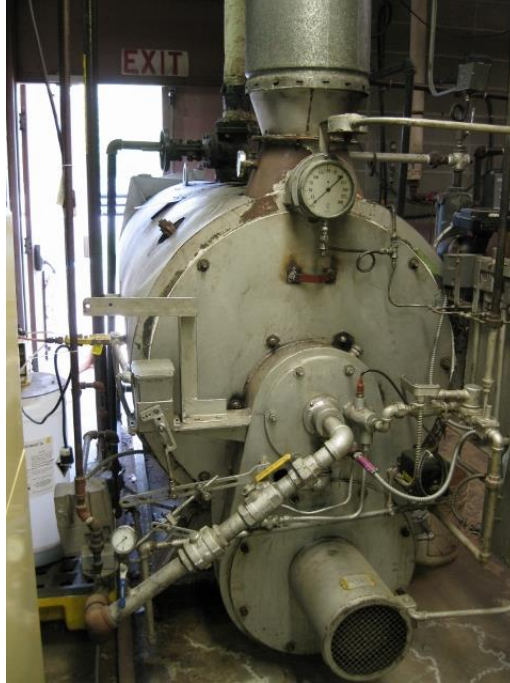
Process Steam Boiler

The facility operates a 20 HP natural gas boiler that produced process steam and heat for office space.

The boiler used for process steam uses natural gas.

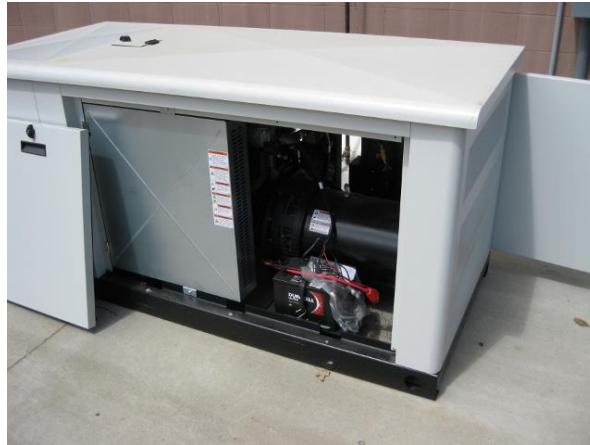
Natural Gas Generator

Recently, the facility installed a new 35 kW natural gas emergency generator made by Milbank. The generator will be used during power loss situations and will provide power for the

information systems and office lighting.

The new generator uses natural gas and is likely subject to the NSPS requirements for new engines.

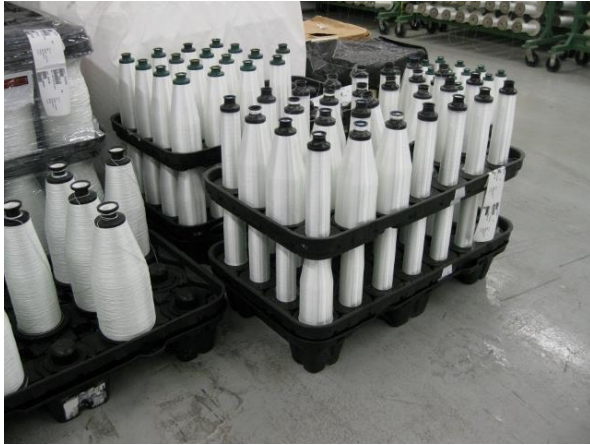
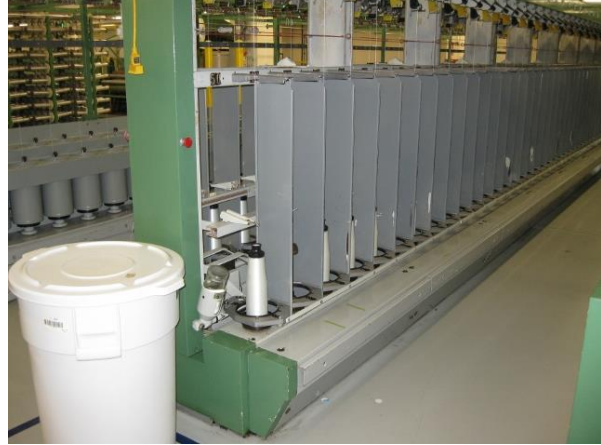
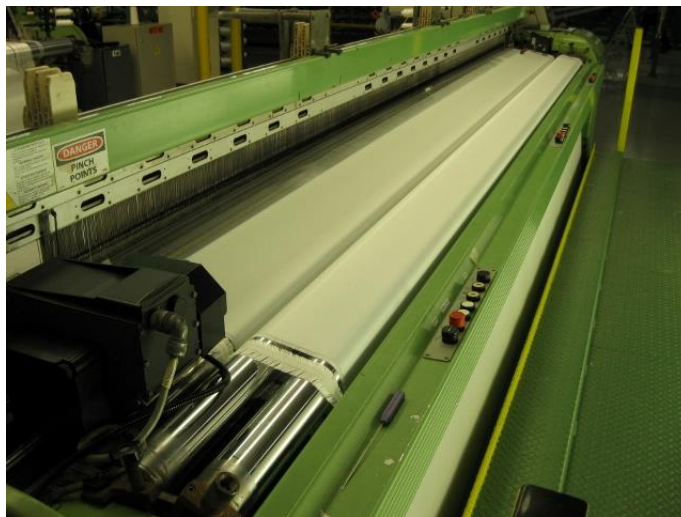
Weaving Fiberglass

The facility begins by producing a fiberglass textile from fiberglass thread. The resultant textile is then coated with a Teflon liquid.

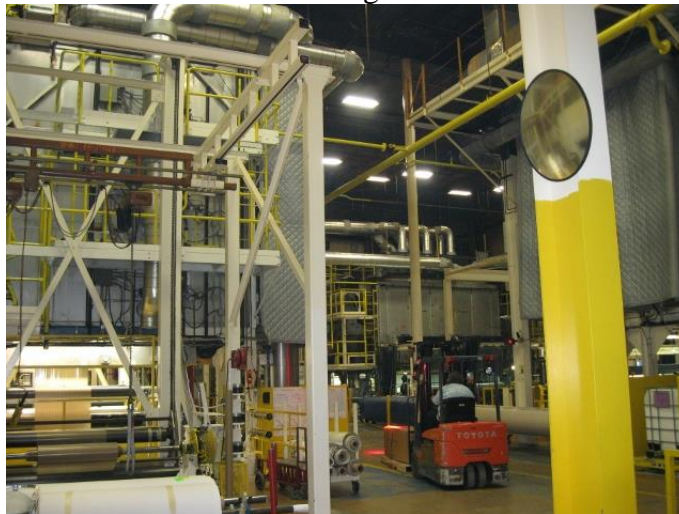
Teflon Coating Machines

Teflon is coated on to the fiberglass textile (fabric) at different thicknesses and grades on 13 different coating machines. Approximately four coating machines share the same stack.

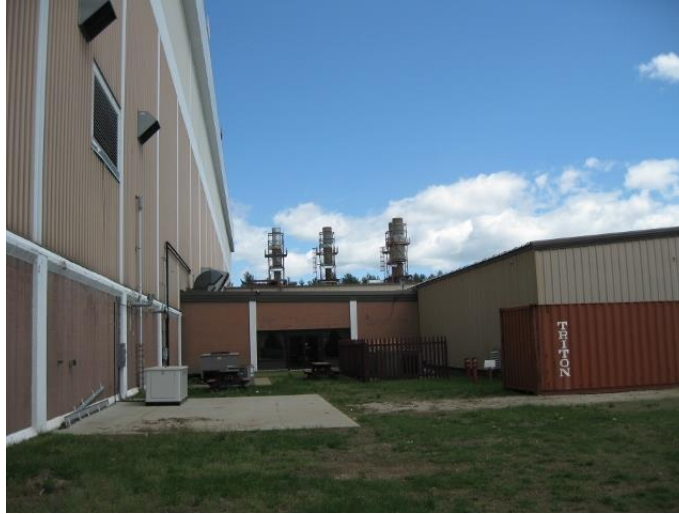
Coating Machine Stacks

The inspector did not observe any significant opacity emanating from the stacks during the inspection. Clouds can be observed in the background of the stacks in the photo above.
